Manhole Inspection Summary

Manhole # S35CC1021MH

Insp Date: **12/7/06 1:45 PM**

Location Address: **3607 GREENWAY**

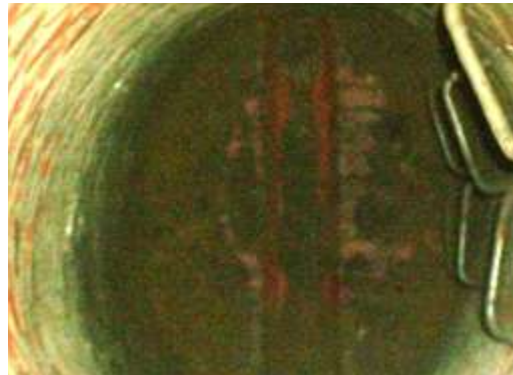
Top View

Infiltration: ☐ None ☐ Joint ☐ Cracks ☐ Mortar ☐ Roots ☒ **Wall**

Bench ☒ Exists Material: **Brick** ☐ Parged ☒ **Debris** (not Condition related)

Channel Material: **Brick** ☐ Parged ☒ **Debris** (not Condition related)

Barrel infiltration. Bench and Channel debris.

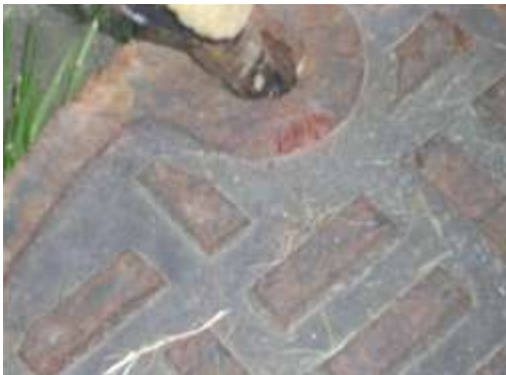
Defect

Type: **Sanitary** Condition: **Worn** Cover Material: **Cast Iron**

Worn cover.

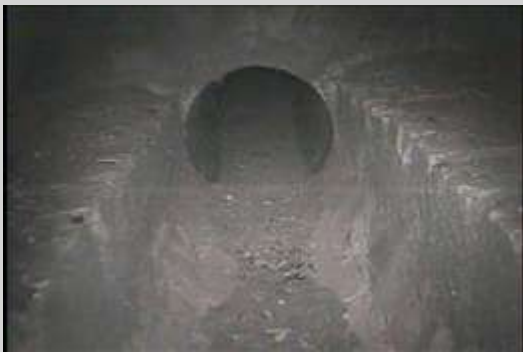
8 in. Circular Gravity Sewer Pipe Out @ 12 O'Clock

Deposits: ☐ None ☒ **Mud** ☐ Sludge ☒ **Debris** ☐ Grease

Silt Depth: **0.5** (in.) Deposits Extent: **Light**

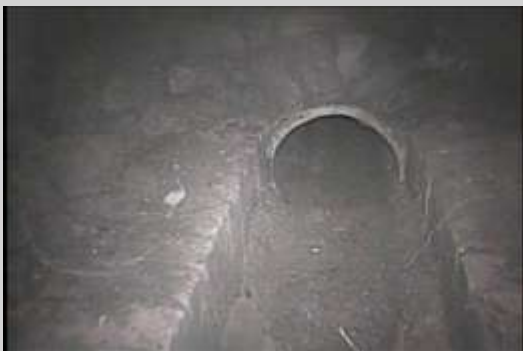
8 in. Circular Gravity Sewer Pipe In @ 6 O'Clock

Deposits: ☐ None ☒ **Mud** ☐ Sludge ☒ **Debris** ☐ Grease

Silt Depth: **1** (in.) Deposits Extent: **Light**
